**Omega Hydrotechnics Ltd**  
**Statement of Company Capabilities**

28<sup>th</sup> February 2025

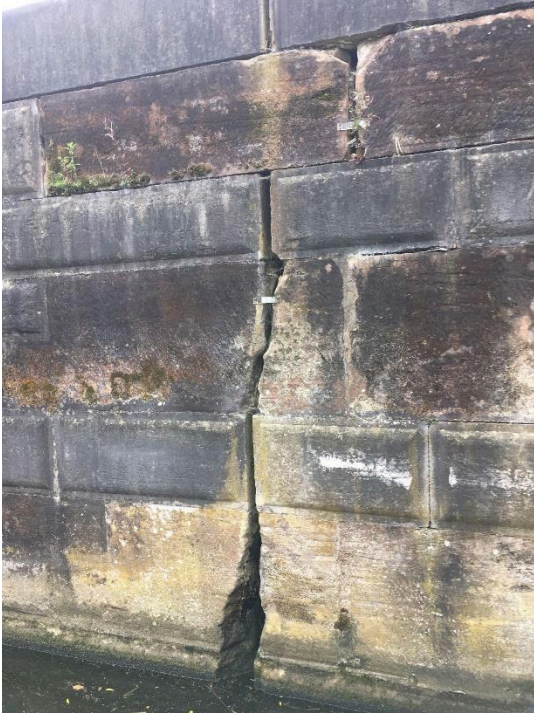
Pre-start Photo of one of the cracks within the narrow lock wall

The final agreed solution involved installing a grout curtain behind the existing narrow lock wall over a length of 14m to a depth of 10m and inject polyurethane resin to seal all leak paths between the locks.

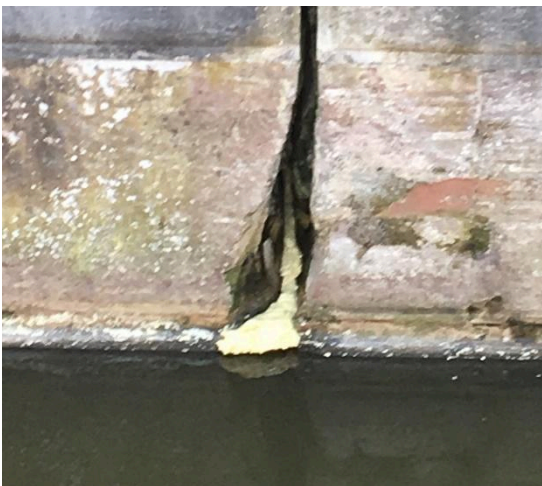
Completion photo following injection.  
Resin has expanded through the ground strata from an injection depth of 10m into the existing structure and sealed the leak.

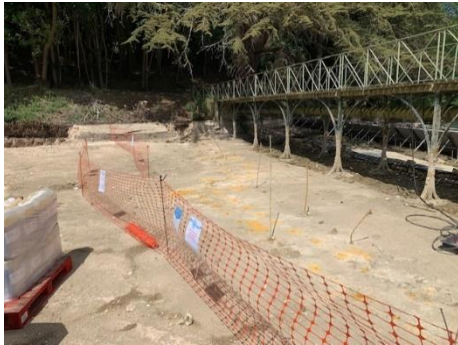
Phase 1 of the works involved the installation of a 60m grout curtain to a depth of 3m. At this time, this is the largest polyurethane resin grout curtain injected in the UK.

The solution was 2-fold, the first involved in installing a 60m long grout curtain to a depth of 3m to prevent water from the lake passing through fissures under the approach washing out underneath the structure of the Grand Cascade.

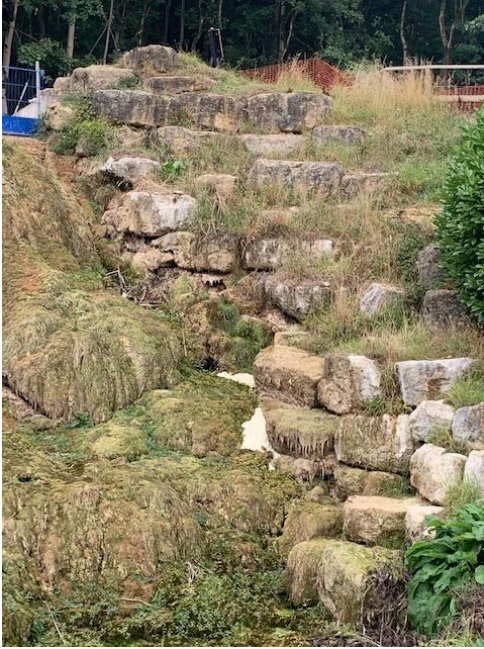
Phase 2 involved sealing voids and fissures beneath the Grand Cascade. Expanded resin can be seen within the main structure.

The second part of the works involved injecting resin through the Grand Cascade structure to seal up voids and leak paths beneath.

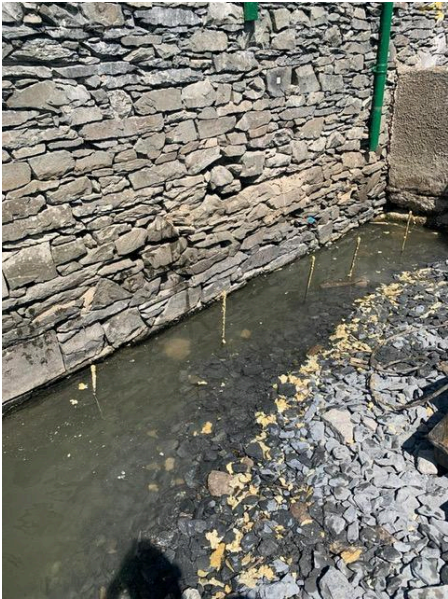
Resin injection down 6m into existing silt layer in lake.

In conjunction with the structural engineer, we developed a solution that involved injecting 6m below the structure into the existing lakebed to stabilise the silts above the hard rock layer and stabilise the original foundation structure.

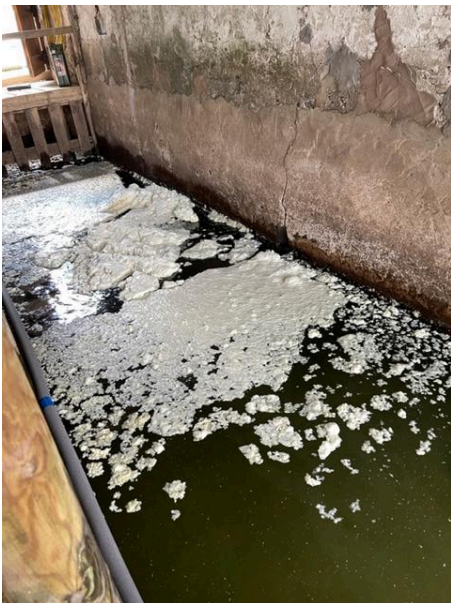
Resin injected has expanded from 6m below through silts and original granular material to surface.

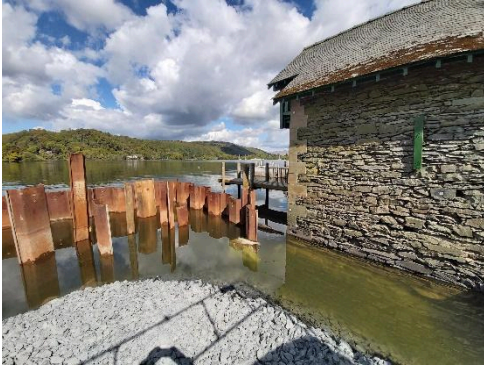
## 5. National Lock Grouting P11643 – Lock 30w HNC

Scope – Omega Hydrotechnics Ltd were tasked to provide a solution to seal existing leaks within the existing lock walls and prevent future movement within the structure. The works were part of the 2020-2021 National lock Grouting.

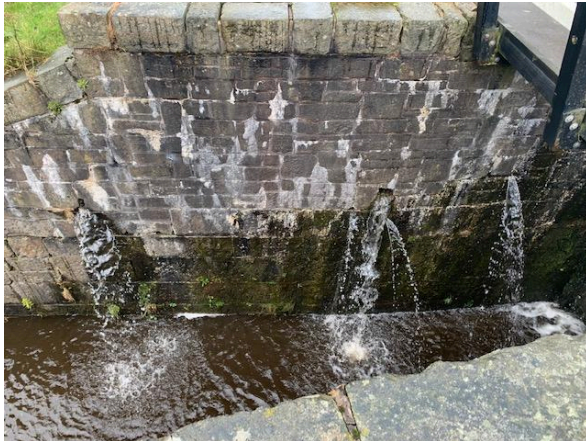
Pre-start photos of existing leaks through lock approach wall from within lock

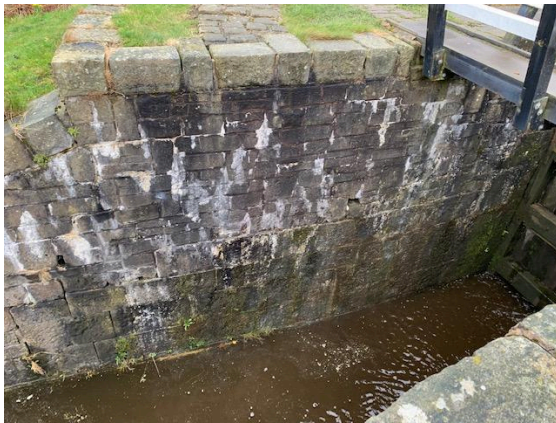
Completion photo showing leaks sealed

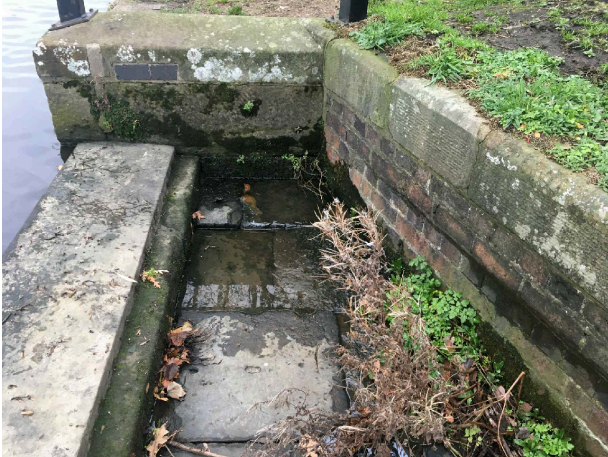
Prestart photos of the spillway wash wall showing extensive leaks passing through.

Scope – Omega Hydrotechnics Ltd were tasked with sealing leaks through the existing reservoir spillway wash wall as part of the remedial works identified in the Panel Engineer 10-year inspection.

Injection depth was 2m below the existing spillway floor.

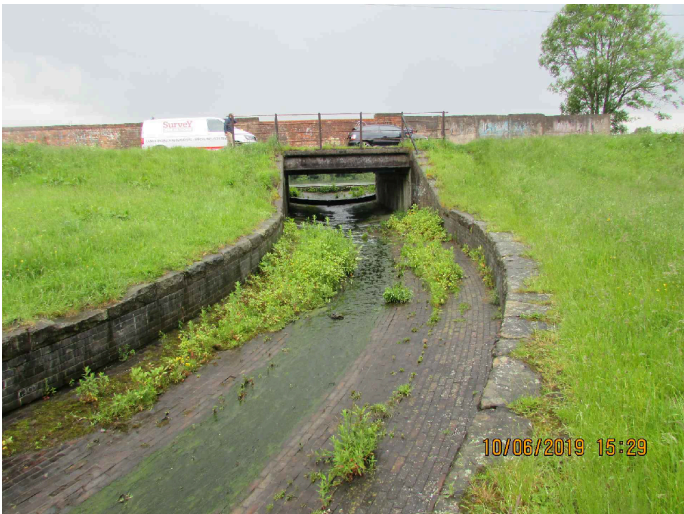
The existing spillway was continuously wet from the leakage through the spillway wash wall.

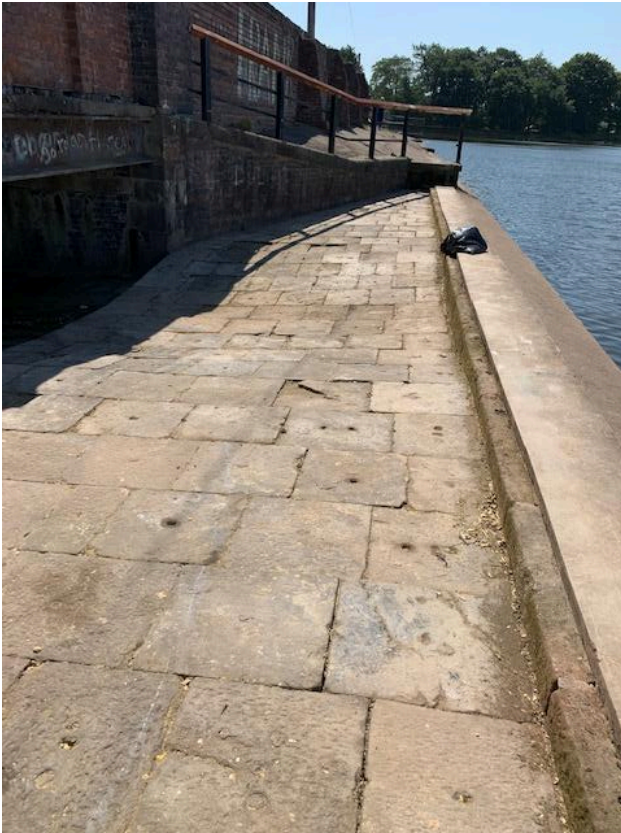
Completion photo of the spillway wash wall completely sealed.  
No water now passes through onto the spillway.

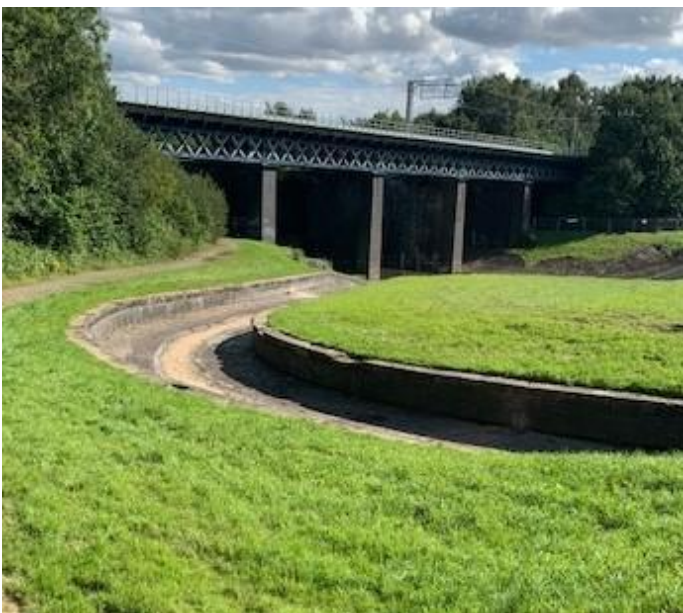
Completion of the existing spillway which following the resin injection had dried out for the first time in several years.

On completion of the works, all leaks had been sealed and the spillway completely dried which was the first time this has happened in a number of years.

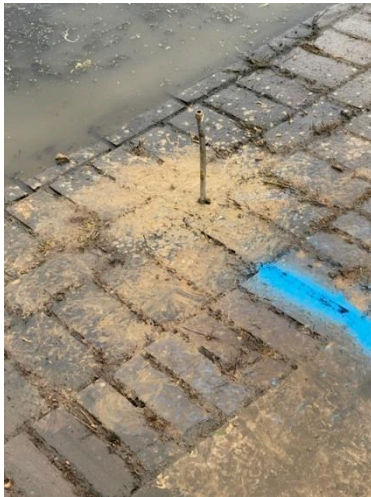
Omega Hydrotechnics Ltd specialist 3m long lances were inserted at 500mm centres and our resins injected to seal the leaks.

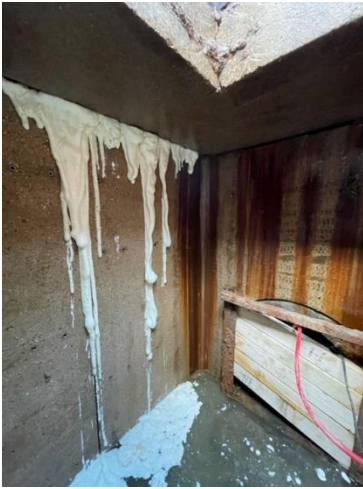
Following injection around the chamber structure, our resins had expanded and sealed all the leaks within the chamber.

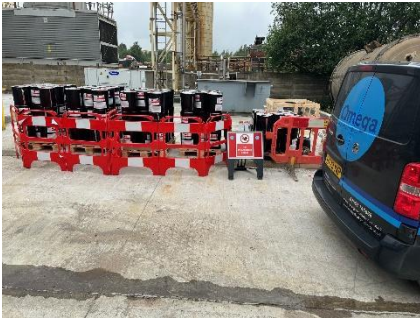
Due to water movement under the bund and structures the silos were starting to move and become unstable.

The solution used was to inject our polyurethane resin under the bund and silos to both stabilise the ground and seal this ground to prevent any future movement. This involved drilling through the base of the bund to a depth of 2m and injecting the resin. This was completed over the whole bund area with injections being placed at 500mm centres in a grid pattern of the whole area.

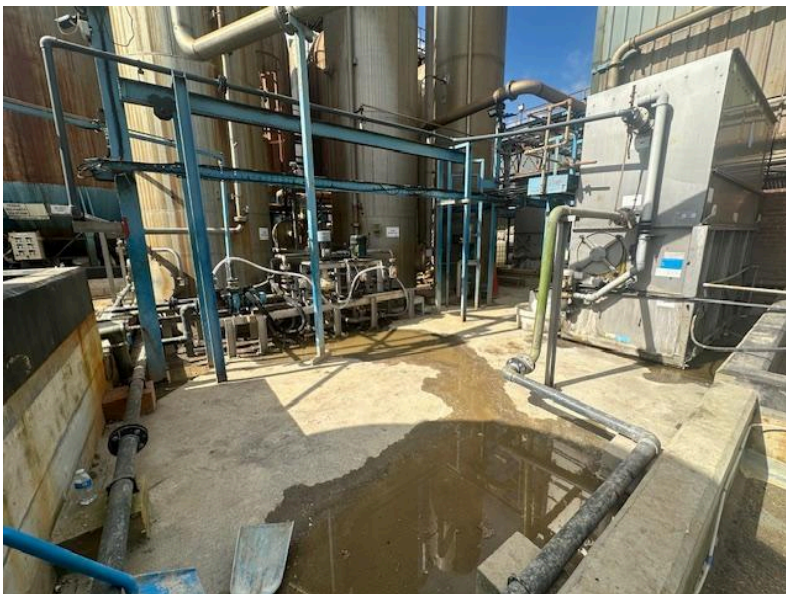
The issues were twofold, ground water passing below had caused the ground to destabilise and this in turn was causing movement of the bund and silos.

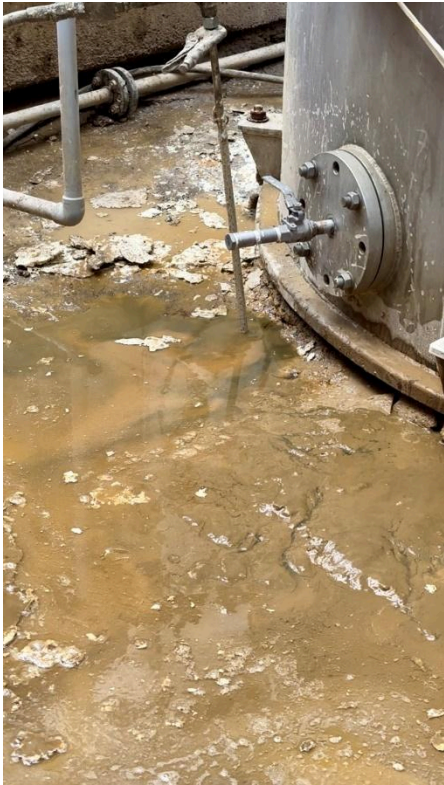
Resin was injected into the ground to a depth of 2m. The resin then stabilised the ground under the bund and silos preventing future movement.

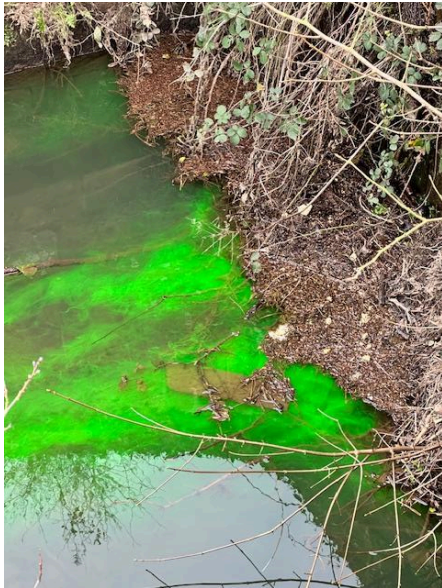
Pre-start dye testing was completed to confirm the exact locations of the leak paths.

Scope – extensive leakage had started to cause damage to the listed aqueduct structure. Omega Hydrotechnics Ltd were tasked with sealing the leaks through the structure to ensure the long-term future of the structure.

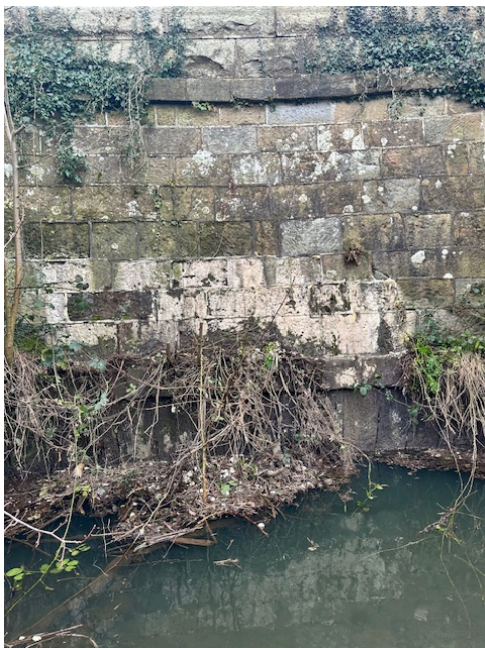
Once the works were completed all leaks had been sealed and the structure protected from any future damage.
